Miscellaneous Paper CERC-93-2  
March 1993

*Coastal Engineering Research Program*

## **Scour Hole Problems Experienced by the Corps of Engineers; Data Presentation and Summary**

*by W. Jeff Lillycrop, Steven A. Hughes  
Coastal Engineering Research Center*

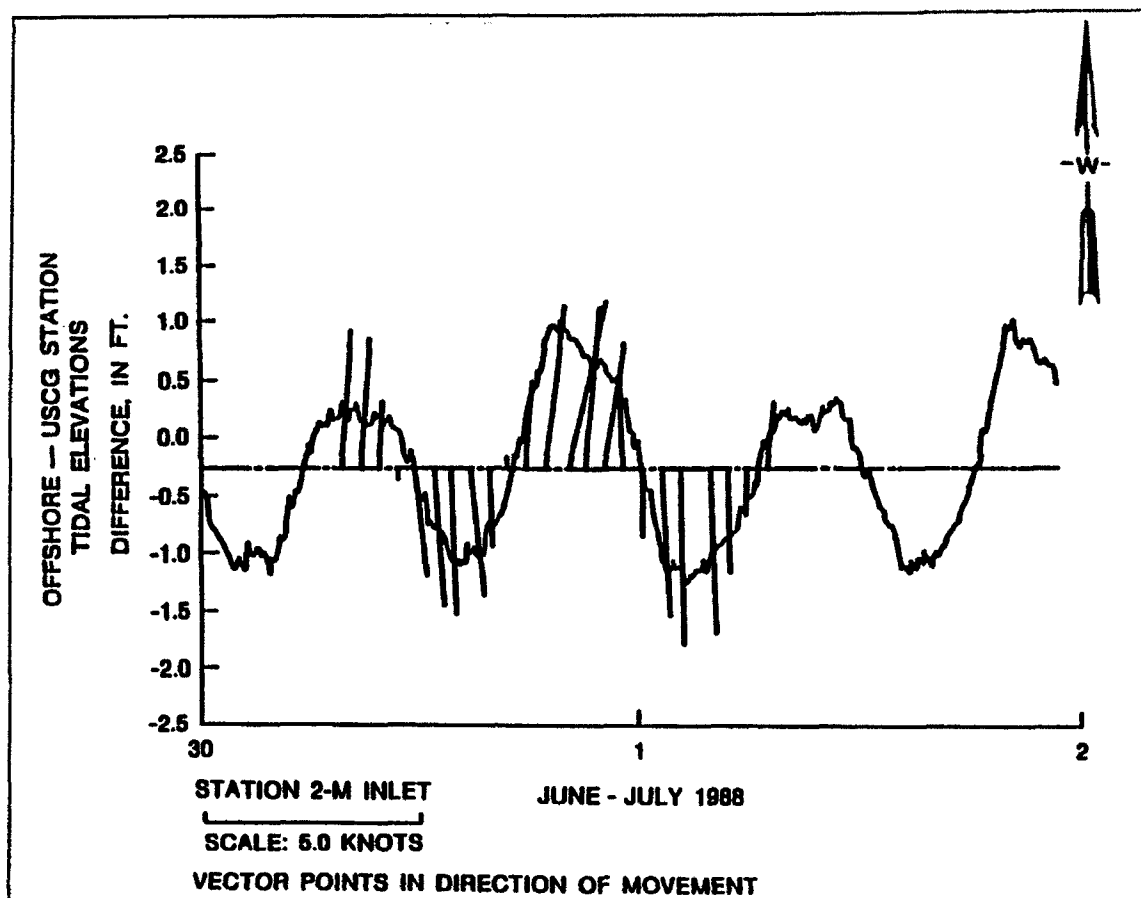
Figure 6. Residual tide signal at Indian River Inlet

The hydraulics of Indian River Bay and Rehoboth Bay have changed dramatically since the inlet was created in the late 1930's. The ebb tidal prism has increased from approximately 27.5 by  $10^6$  cu ft in 1931 to 3.7 by  $10^8$  cu ft in 1948 to 1.5 by  $10^9$  cu ft in 1986. The tide range inside the inlet went from near zero in 1931 to 2.5 ft in 1948 to 2.7 ft in 1986. Inlet velocities increased from 2.4 ft/sec in 1948 to 6.6 ft/sec in 1986, and during field measurements made in 1988, maximum recorded velocities exceeded 8 ft/sec during spring ebb tidal flows. Ocean tides are substantially greater than tides immediately inside the inlet at the US Coast Guard station, as illustrated in Figure 6, which shows the difference in elevation between the two locations.

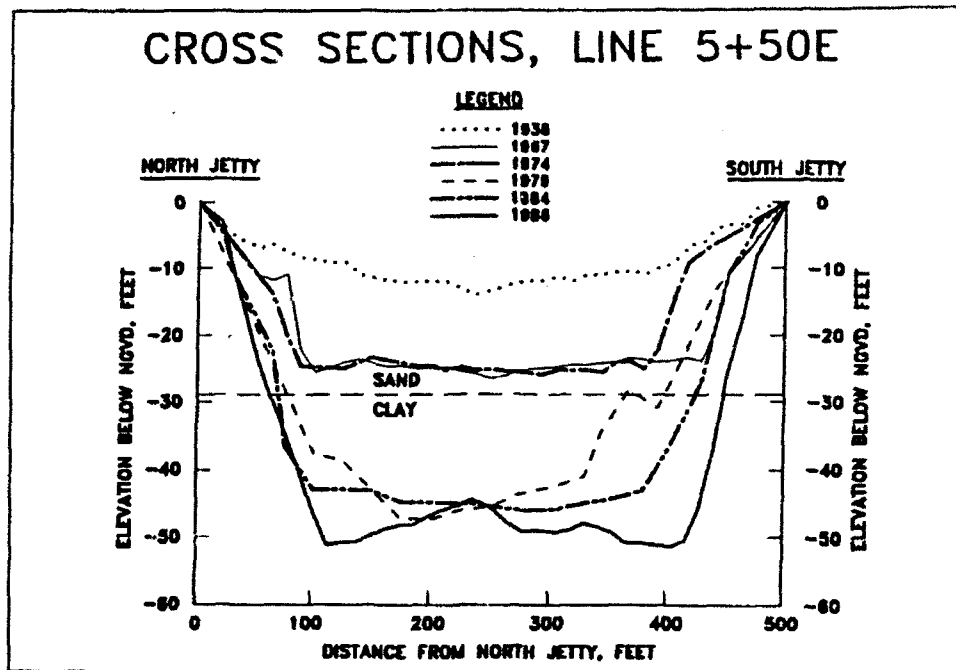
Figure 9. Inlet cross-sectional changes, Indian River Inlet

This could occur either through horizontal enlargement of the extreme scour holes, through overall deepening of the entire inlet, or through a combination of both. Eventually, both jetties could be seriously damaged or even lost as a result of scour hole enlargement and inlet deepening.

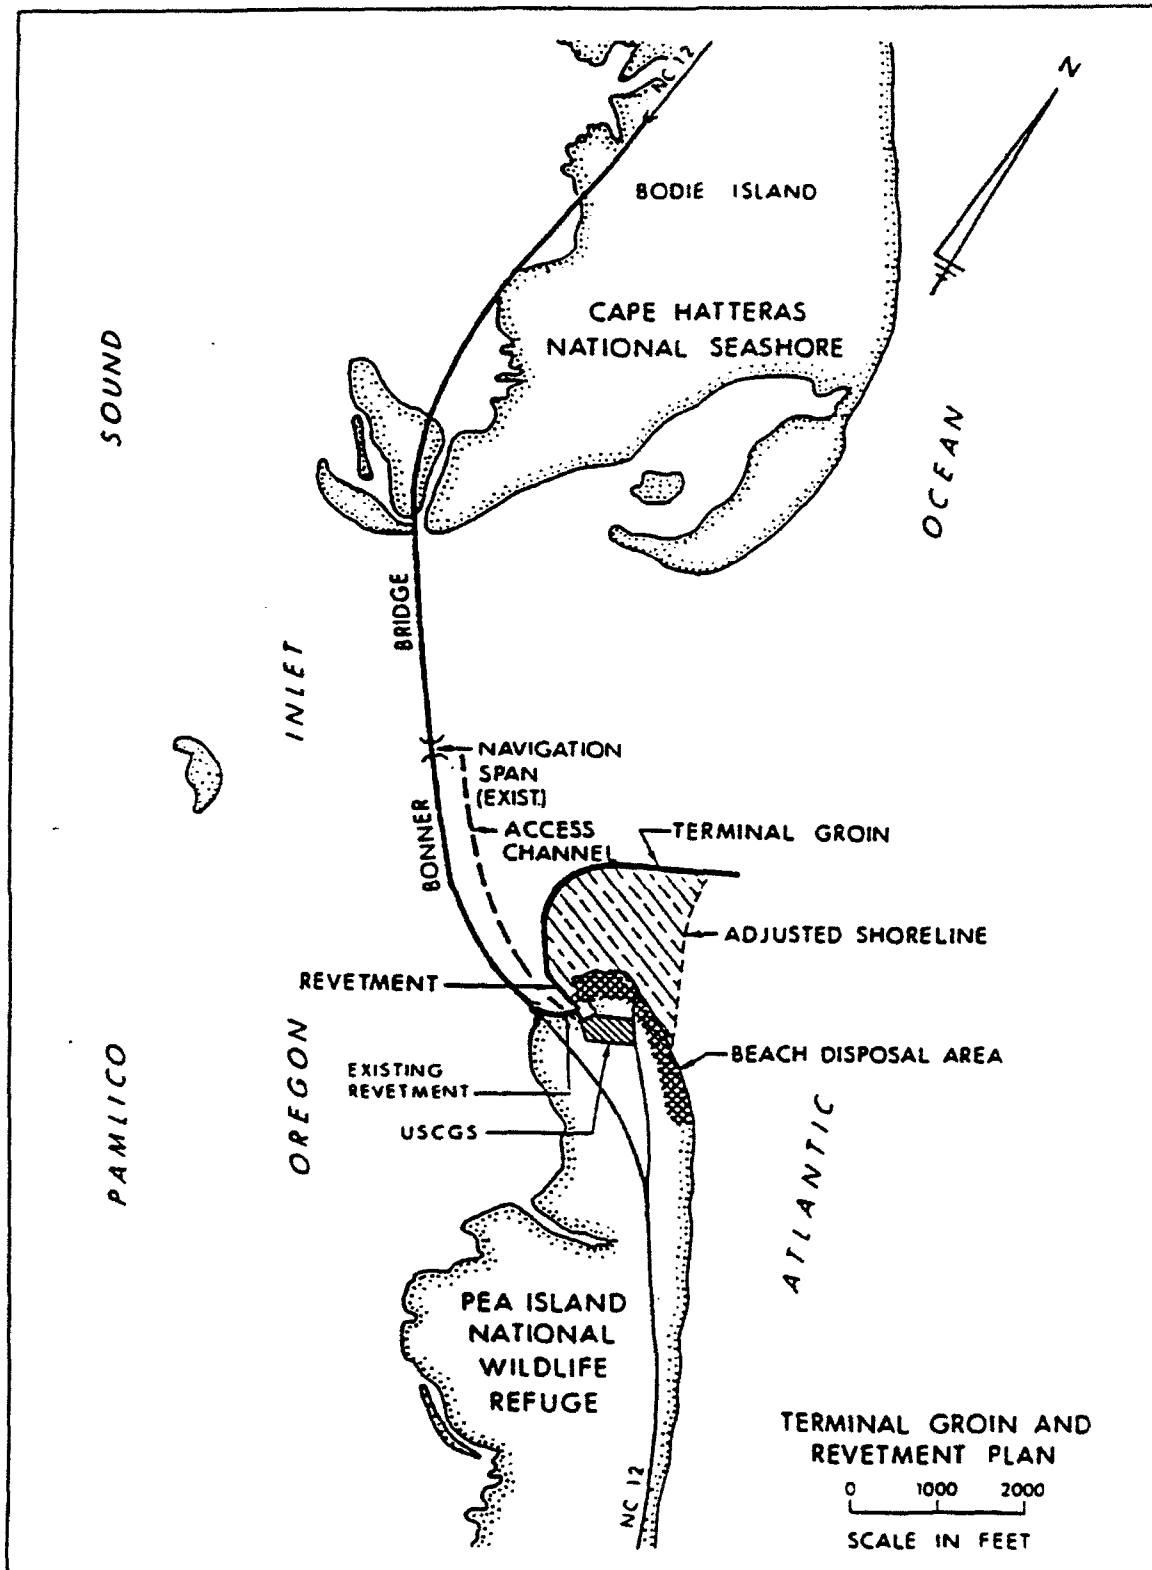
Figure 12. Oregon Inlet and terminal groin

The extent of scour that occurred during construction is shown in Figure 13. Center-line stations on this figure refer to the positions indicated on the terminal groin plan view given in Figure 12.

It was speculated during the May 1991 workshop that the primary cause of scour at Oregon Inlet was the ebb-flow tidal current because the deepest scour was observed on the channel side of the groin. Waves were discounted as a process contributing to the scour because most waves break on the ebb shoal, thus decreasing their effect. However, there is a possibility that nearshore currents generated by waves during storm conditions could have contributed to the scour. Aerial photographs of the groin showed currents being trained along the structure.

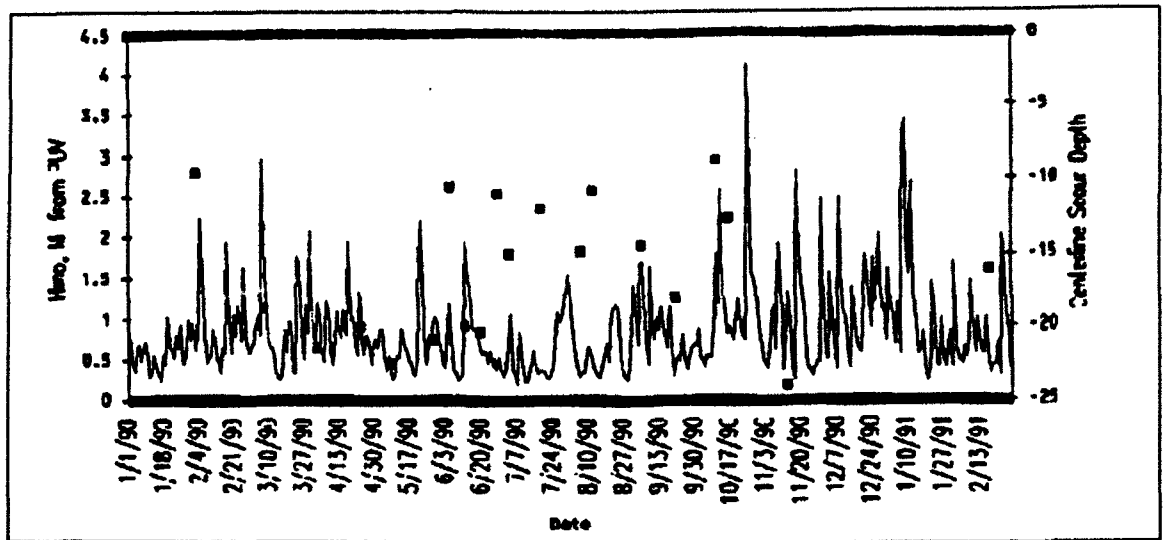
Figure 14. Center-line scour versus wave height

As the groin was constructed, there were periods of scour and no scour (even accretion) as shown in Figure 13. An attempt was made by the monitors to correlate wave height, period, and direction with scour depth. Figures 14, 15, and 16 show that, based on preliminary results from Miller (1992), none of the aforementioned wave parameters correlated with scour depth.

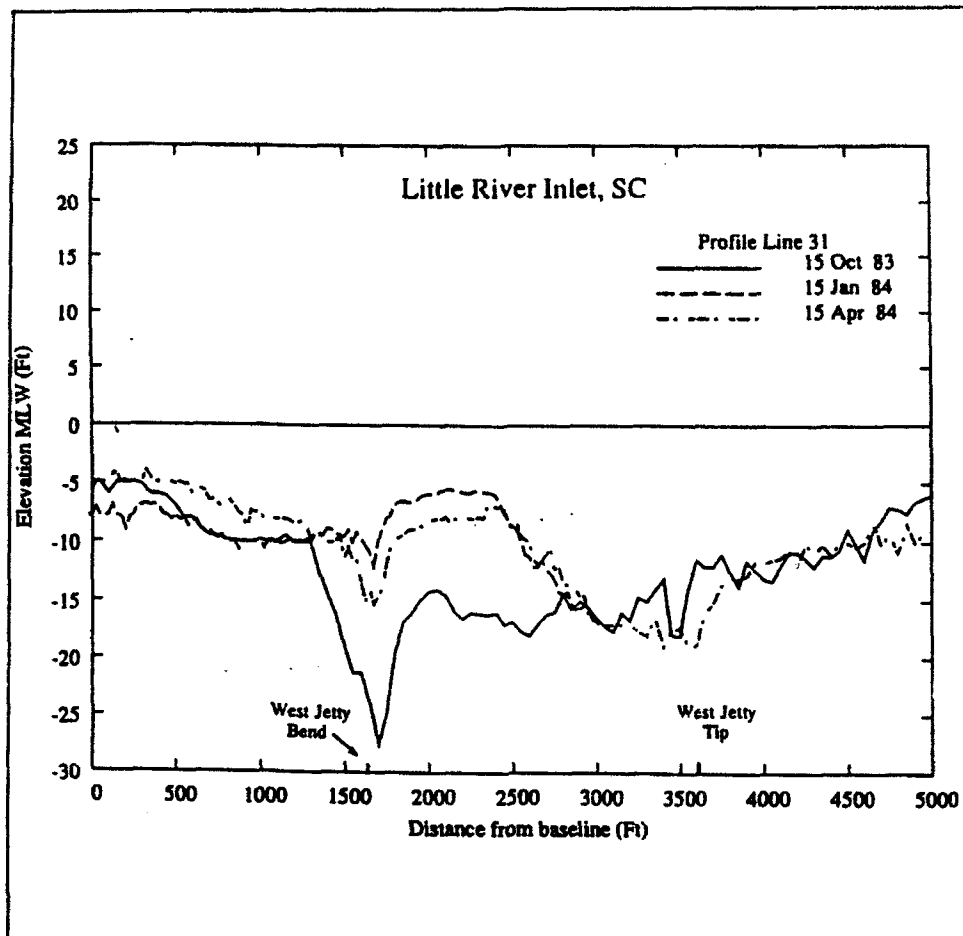
Figure 19. Little River Inlet bathymetry profile

Scour is also occurring along the west jetty adjacent to the inlet channel, and the cause appears to be different from that at the tips. Along this section, natural thalweg migration appears to be shifting the channel toward the jetty, scouring to a depth of about 20 to 25 ft mlw. Prior to construction of the navigation project, the natural channel shifted frequently; and at the time of construction of the west jetty, the natural channel was toward the southwest and Waties Island (Chasten and Seabergh, in preparation). This flow route was closed off as the west jetty was constructed and the ebb tidal flow began channelizing along the west jetty. In December 1983, dredged material from the inlet was placed in the scour hole but has since eroded away, and the hole continues to enlarge. Figure 19 shows a survey taken along the west jetty prior to dredged material placement and following placement. Note that the deepening trend continued immediately following fill placement.

However, scour at the tip of the jetties is continuing, which may eventually result in damage. Chasten and Seabergh (in preparation) stated that collapse of either jetty head section would not immediately affect the functionality of the jetties to stabilize the inlet, and reported that the rate of scour at the west jetty has slowed.

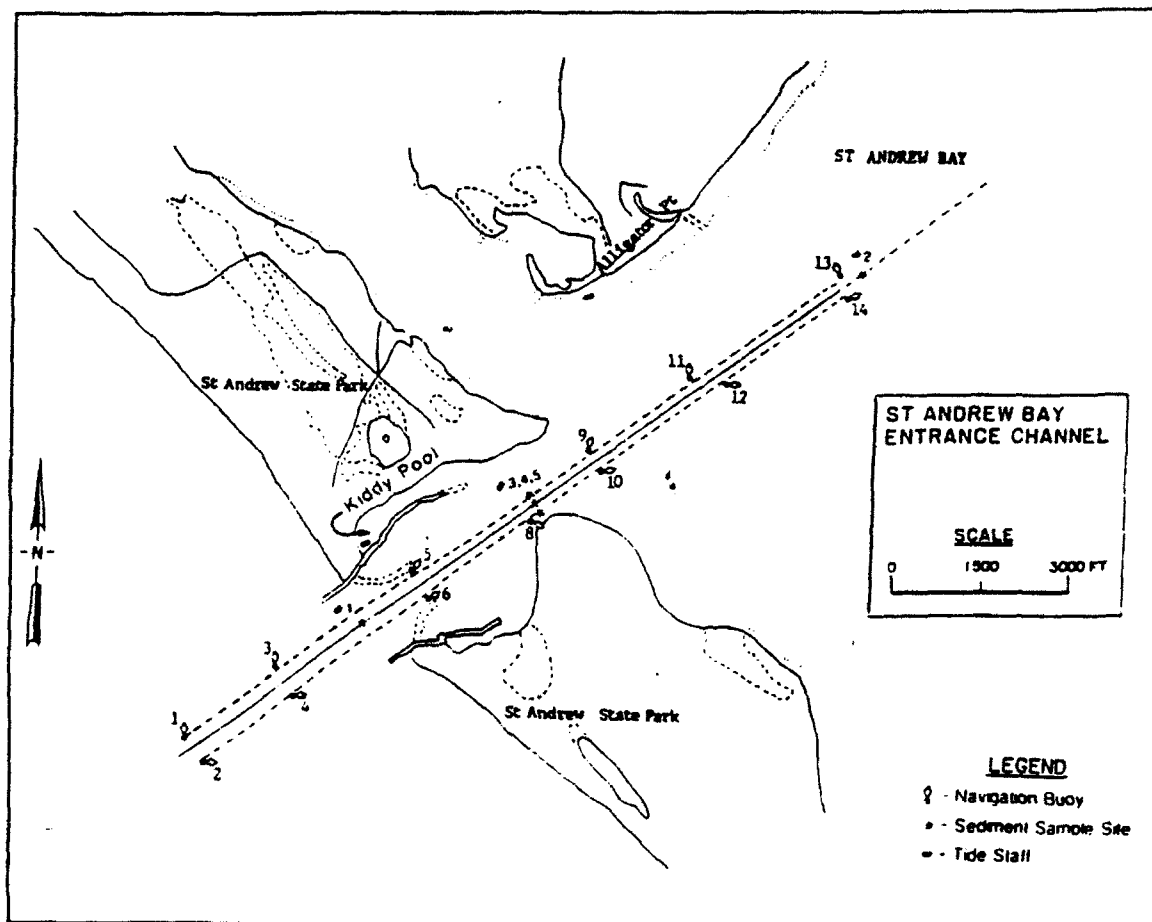
Figure 24. Entrance channel at Panama City

The channel was dredged across the Land's End Peninsula, creating an entrance channel, and the jetties were built to stabilize the inlet. The jetties were constructed of riprap and extended to the -12-ft mlw offshore depth contour. These jetties were built on rock mattresses with steel sheet-pile cores along the jetty axis (Lillycrop, Rosati, and McGehee 1989). The east jetty extended from the low water line 500 ft offshore, and the west jetty from the low water line 550 ft offshore. Both jetties had a crest elevation of +6 ft mlw. The jetties were extended landward to mitigate severe erosion occurring along the inlet's channel banks (Figure 24).

The jetties and extensions have required continuous maintenance since they were completed in 1934. Since 1950, over 65,000 tons of stone have been required, much of which has been used to rehabilitate the west jetty tip. Following construction, the inlet stabilized with the natural channel thalweg located adjacent to the west jetty. As seen on Figure 25, the federally authorized navigation channel is located along the center line of the inlet. However, the inlet's thalweg is located adjacent to the west jetty where natural depths are greater than -40 ft mlw. Armor stones are displaced during storm events, and foundation materials and armor stones are lost as scour and deepening around the jetty tip continues.

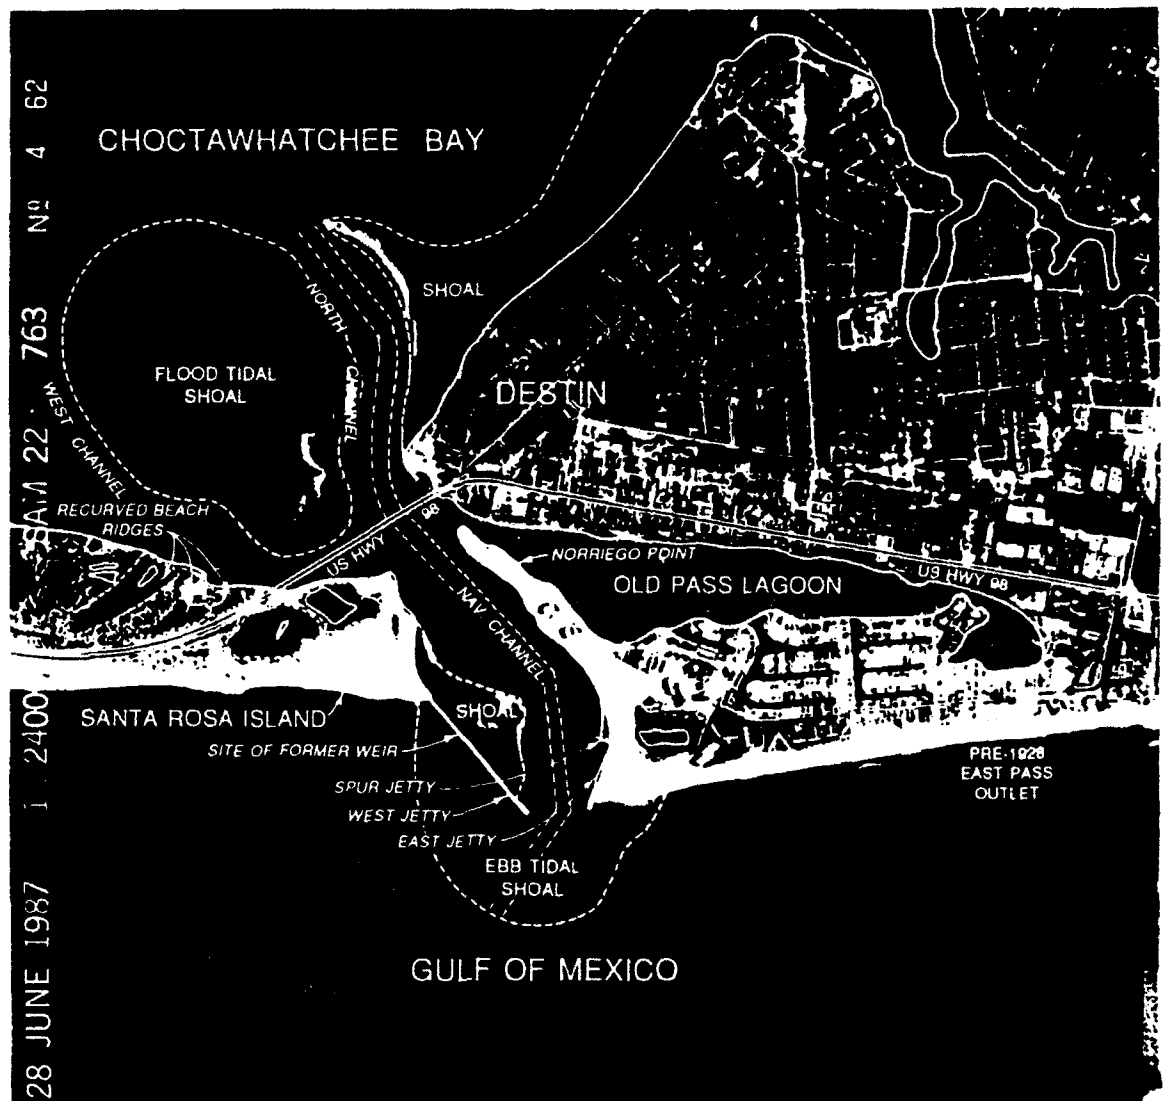
Figure 27. East Pass navigation project (Morang 1992)

entrance. This was done by constructing a 300-ft-long spur jetty perpendicular to the landward end of the east jetty and extending out into the channel. The object was to deflect the strong ebb tidal currents that were causing erosion. It was feared that if the erosion was left to continue, the main jetty would be undermined.

In the 1980's, a 55-ft-deep scour hole developed that ultimately resulted in the loss of the spur dike at a rate of nearly 100 ft/year. This scour hole represents scouring nearly 25 - 30 ft below the normal bottom depth in the area. Figure 28 shows a plan view of the location of the scour hole at the spur groin and another scour hole at the tip of the west jetty.

In 1984 a study of the inlet and scour problem was initiated under the Monitoring Completed Coastal Projects (MCCP) research program, funded by the Office, Chief of Engineers. The study, completed in 1991, postulated "physical processes are still attempting to force the inlet east" toward its former stable location. The driving mechanisms are wave forces from the predominantly southwest direction, and flood-tidal shoal geometry and interaction with tidal currents. These cause natural thalweg migration to the east that has progressed so that the thalweg now lies adjacent to the east jetty and spur groin.

To minimize adverse scour, the report recommends the following (Morang 1992):

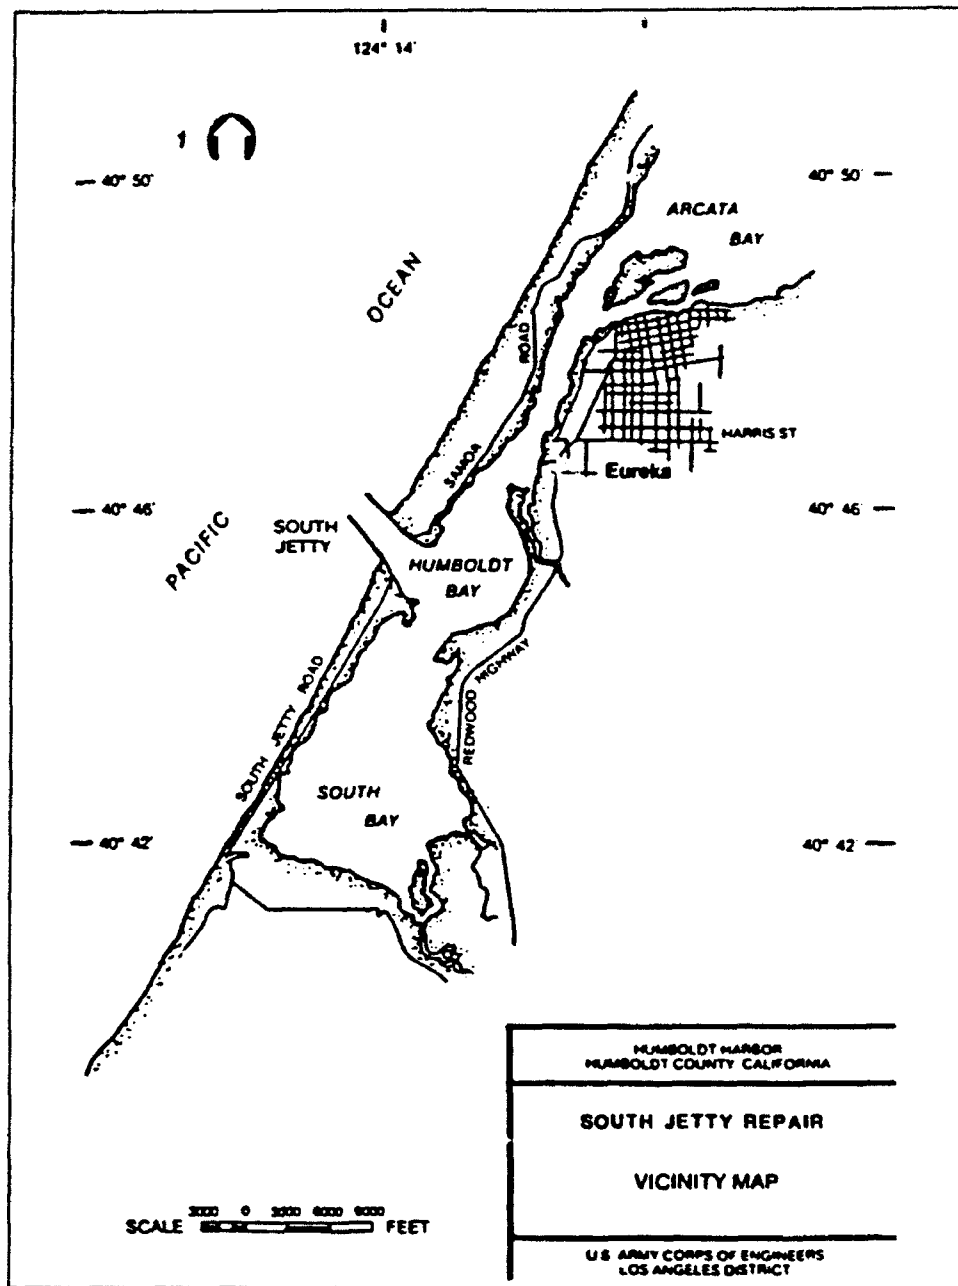
Figure 32. Humboldt Bay entrance channel

Bathymetric data show three areas with significant active seasonal changes. Two are off the southwest side of the two jetty heads, and the third is along the channel side of the south jetty. The large holes tend to scour in the summer and fill in the winter. Off the south jetty head, soundings indicated depths almost to -70 ft mllw in August 1983 at station 85+50 and 350 ft off the center line. Surveys in 1984 showed this area had shoaled to -40 ft mllw in April,

which was the most extreme shoaling between the two survey periods. The two scour holes adjacent to the jetty tips are slightly linear in shape, parallel with the jetties and deepest close to the toe. The hole at the north jetty is considerably larger ranging from 200 to 300 yd wide. Historic soundings do not show the scour holes so they are believed to be a modern feature. The thru scour hole lies adjacent to the south jetty trunk between stations 47 and 62. It is approximately 100 yd wide, reaching depths greater than -60 ft mllw. Comparison with historic bathymetry show that, unlike the first two scour holes, this one has been present since construction of the jetties. Diver

The foundation materials under both jetties range from fine to medium fine sand, with the predominant material being poorly graded fine sand. With this range of material, currents exceeding approximately 3 ft/sec cause transport. Tidal currents at Humboldt have been measured in excess of 7 ft/sec by the U.S. Geological Survey. The inlet cross section is shallow on the north side, which reduces current speed on this side of the inlet and focuses it on the south side. Scour is occurring on the south side. The location of the scour holes at the jetty tips appears to be caused by a structure/longshore current interaction.

The structures at Humboldt Bay experience three types of scour, each apparently governed by different hydrodynamic processes. The first type of scour is caused primarily by the ebb-flow jet exiting the northerly interior channel, flowing diagonally across the entrance channel and impinging on the rubble-mound revetment on the south side of the entrance channel. This has resulted in scouring of the bottom near the toe of the south jetty along part of its length. Depth of scour was reported to be 60 - 70 ft.

During the winter, when the rip currents scour a channel on the outside of the south jetty and the ebb currents scour near the toe on the inside of the jetty, the combined effect puts the structure in considerable danger of liquefaction-related failure.

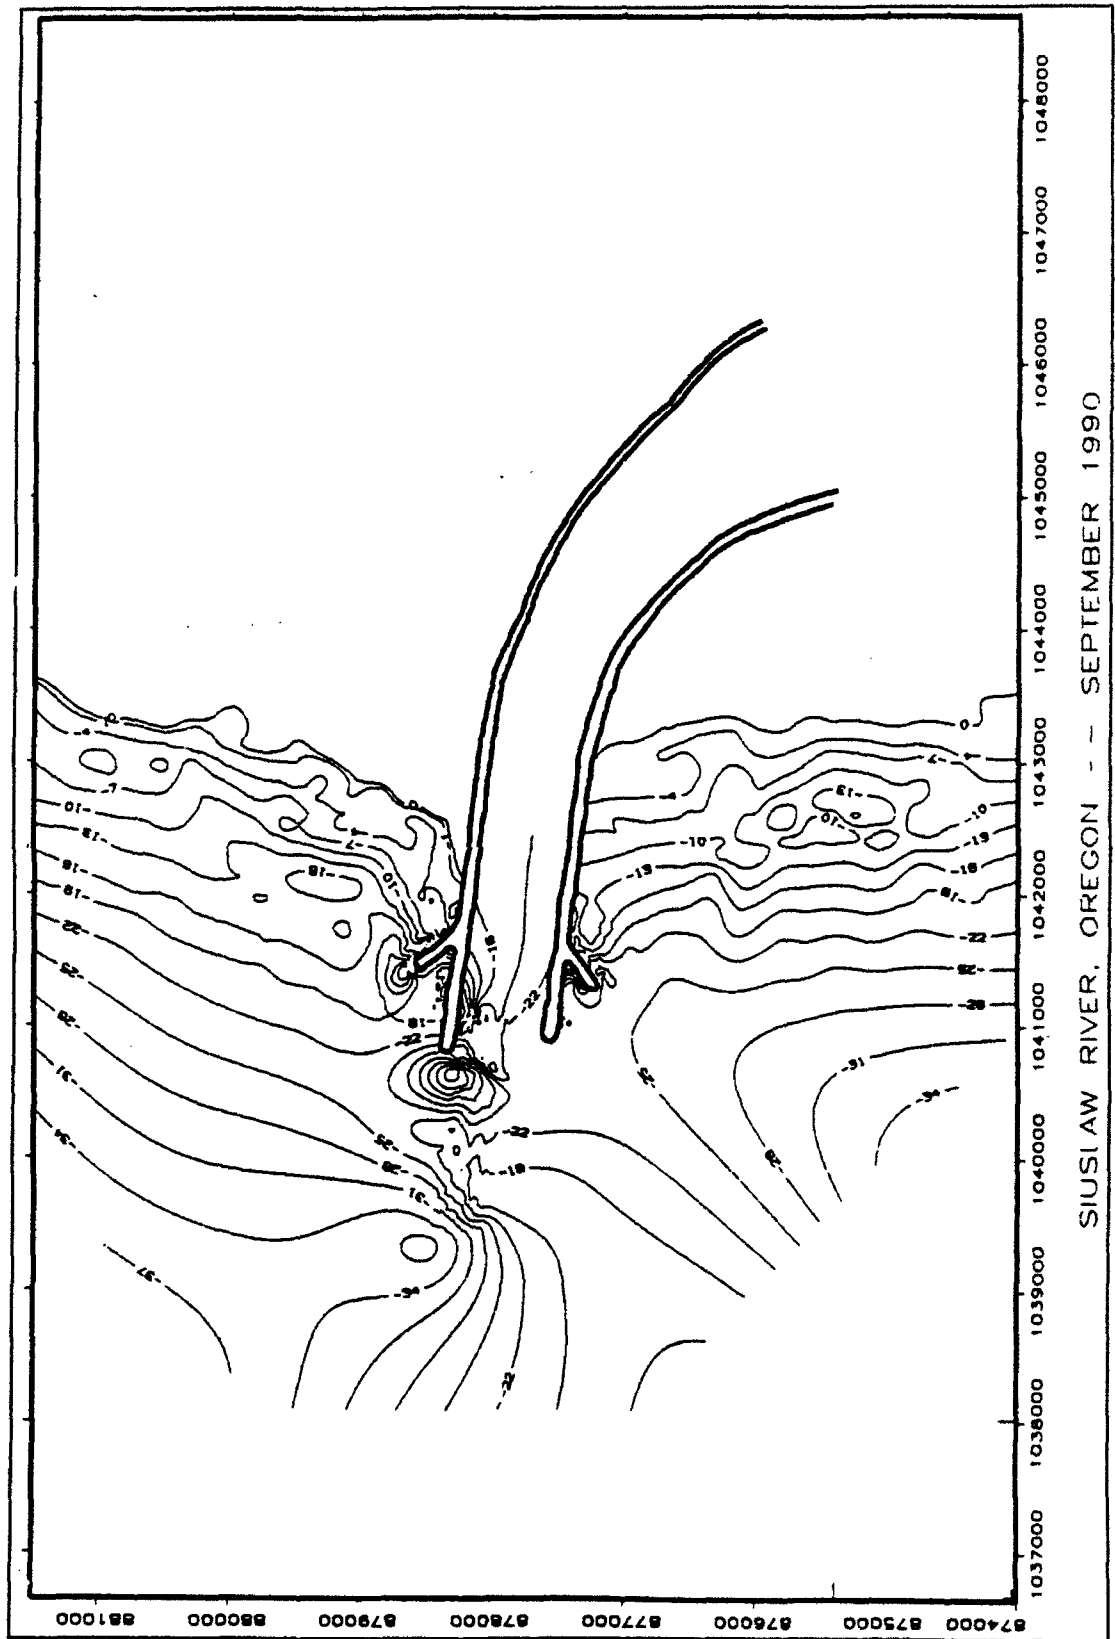
Figure 34. Jetties and bathymetry at Siuslaw River Entrance

Two scour problems are occurring at Suislaw. The first problem, seen in Figure 34, is caused by longshore currents flowing from the north to south. The currents reach the north jetty and are deflected seaward along the jetty as a rip current. The current velocities are sufficient to scour a trench along the toe of the structure, thus giving concern for the integrity of the rubble mound. The scour trench extends along the spur jetty as well.

The second scour problem is occurring inside the entrance on the north side of the channel. River currents that flow toward the sea are deflected around a corner by the stabilized channel. Where this change of flow direction occurs, a large scour hole has developed. Maximum depths in the scour hole are about 40 ft below mllw, while depths in the adjacent channel average about 20 ft. Because the scour hole is located immediately adjacent to a bank revetment, there is potential for toe failure and subsequent deterioration of the revetment.

The types of scour observed at Suislaw are similar to the problems occurring at Humboldt Bay. The scour trench caused by the longshore currents meeting the north jetty is most likely seasonal, with the trench filling in during calmer periods. The effectiveness of the spur jetties is being evaluated in the MCCC Program.

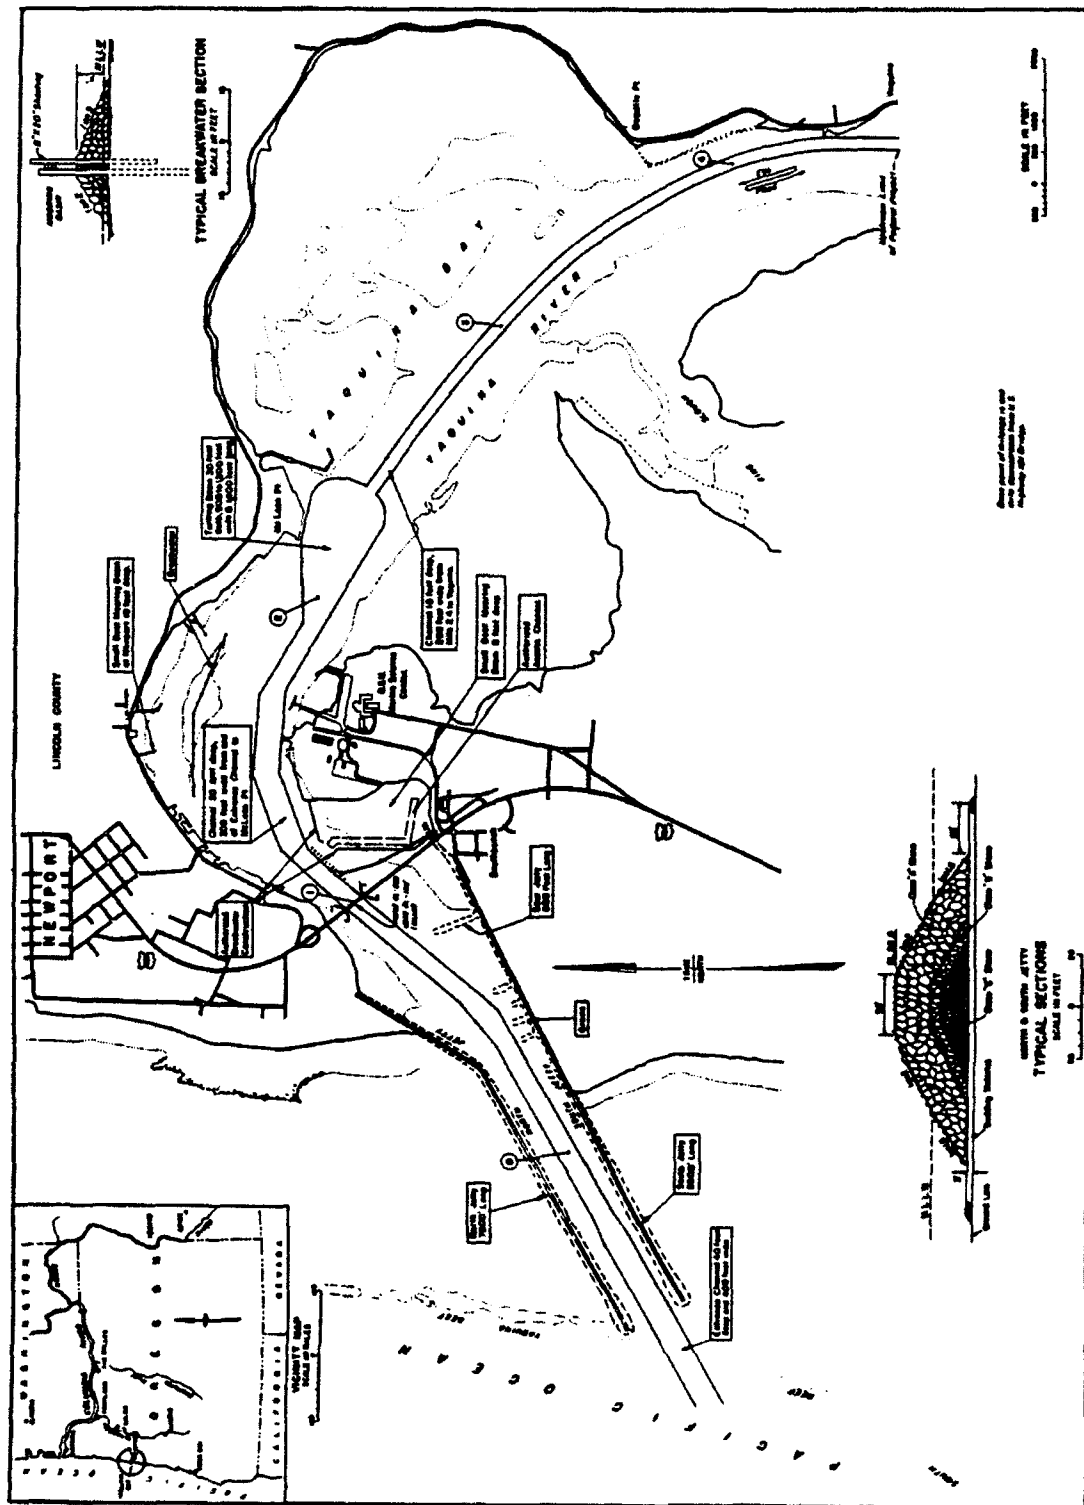
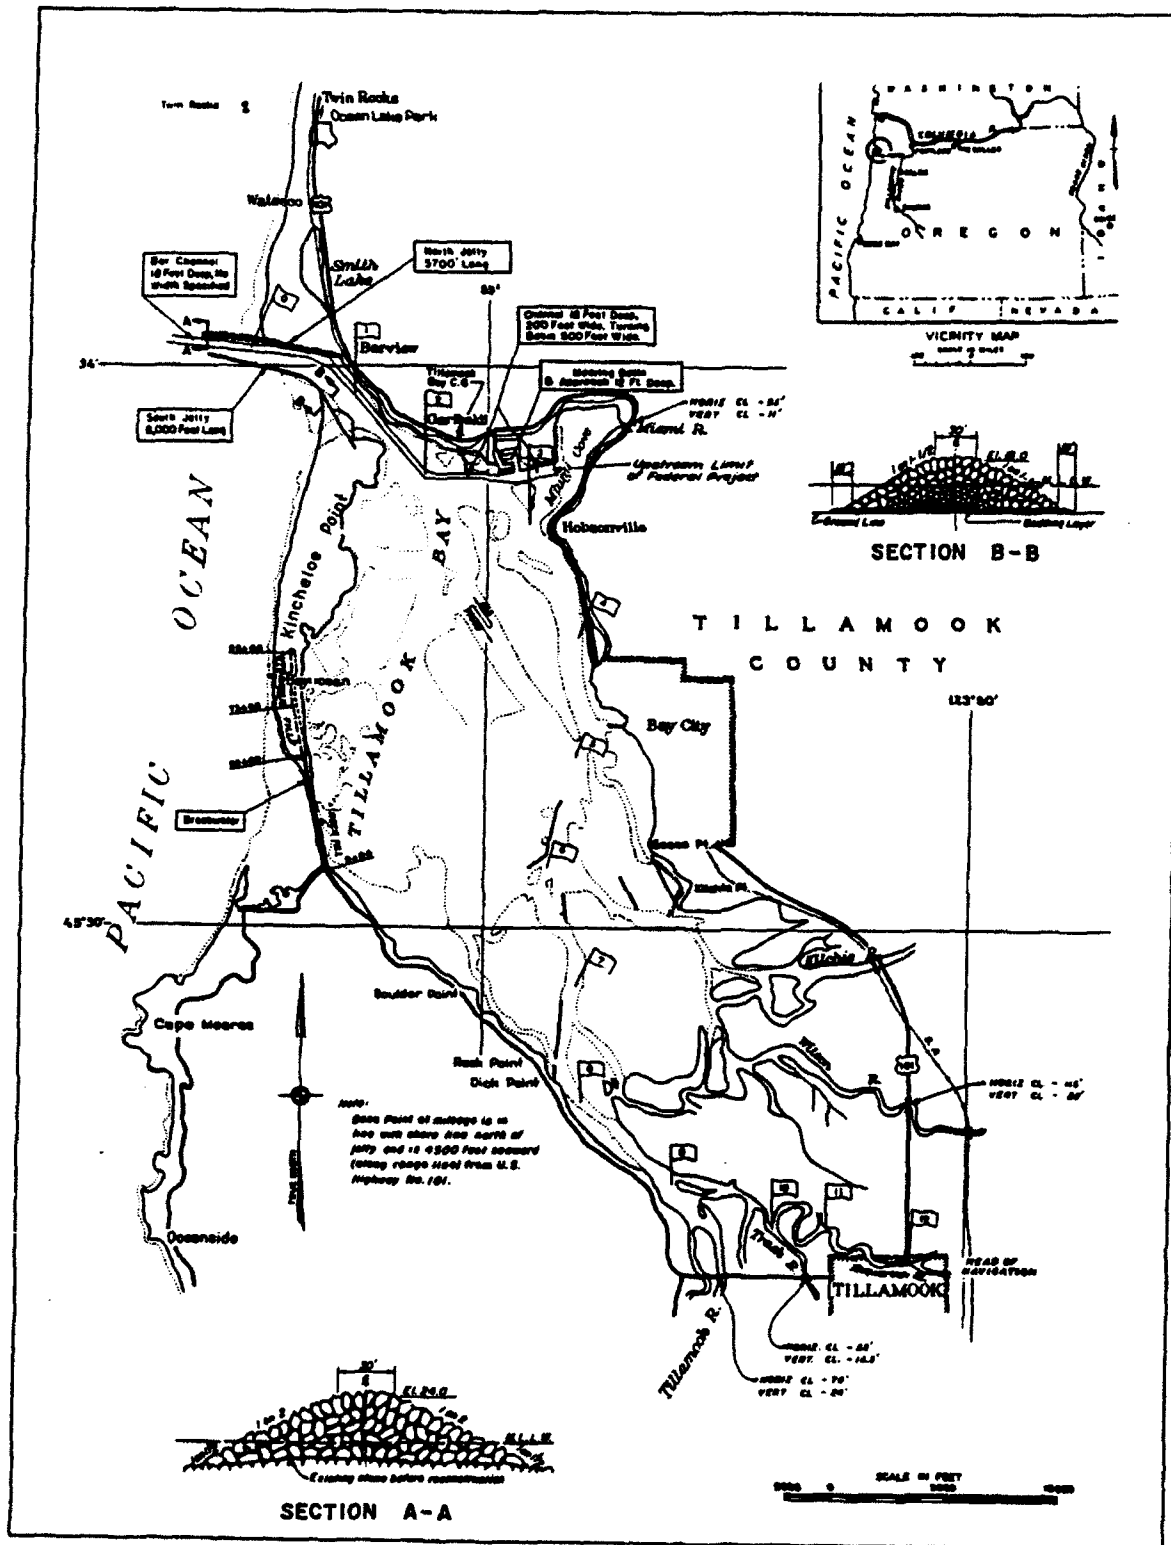
Figure 36. Tillamook Bay and Bar, Oregon, site location map

Scour accompanying construction of the south jetty was generally on the order of 5 - 10 ft below normal depths, and it occurred just ahead of construction. Scour holes have formed at the tips of both jetties. Surveys dated 1987 indicate a large kidney-shaped scour hole at the tip of the south jetty having a maximum depth of about 61 ft below mllw (Figure 37). Surrounding depths average about 30 - 40 ft. The authorized channel depth is 24 ft. There was once a scour hole at the tip of the north jetty, but it has disappeared along with 300 ft of the north jetty. The end of the north jetty was recapped during the summer of 1991.

A scour problem also exists along the channel side of the north jetty well inside the entrance channel. The shape and location of this hole indicate that it is probably formed by ebb-flowing currents exiting the bay and being directed by the geometry across the channel to the north side. The hole is about 50 ft deep while the surrounding area has a depth closer to 25 ft. The proximity of the hole adjacent to the structure causes concern about erosion of the structure toe.

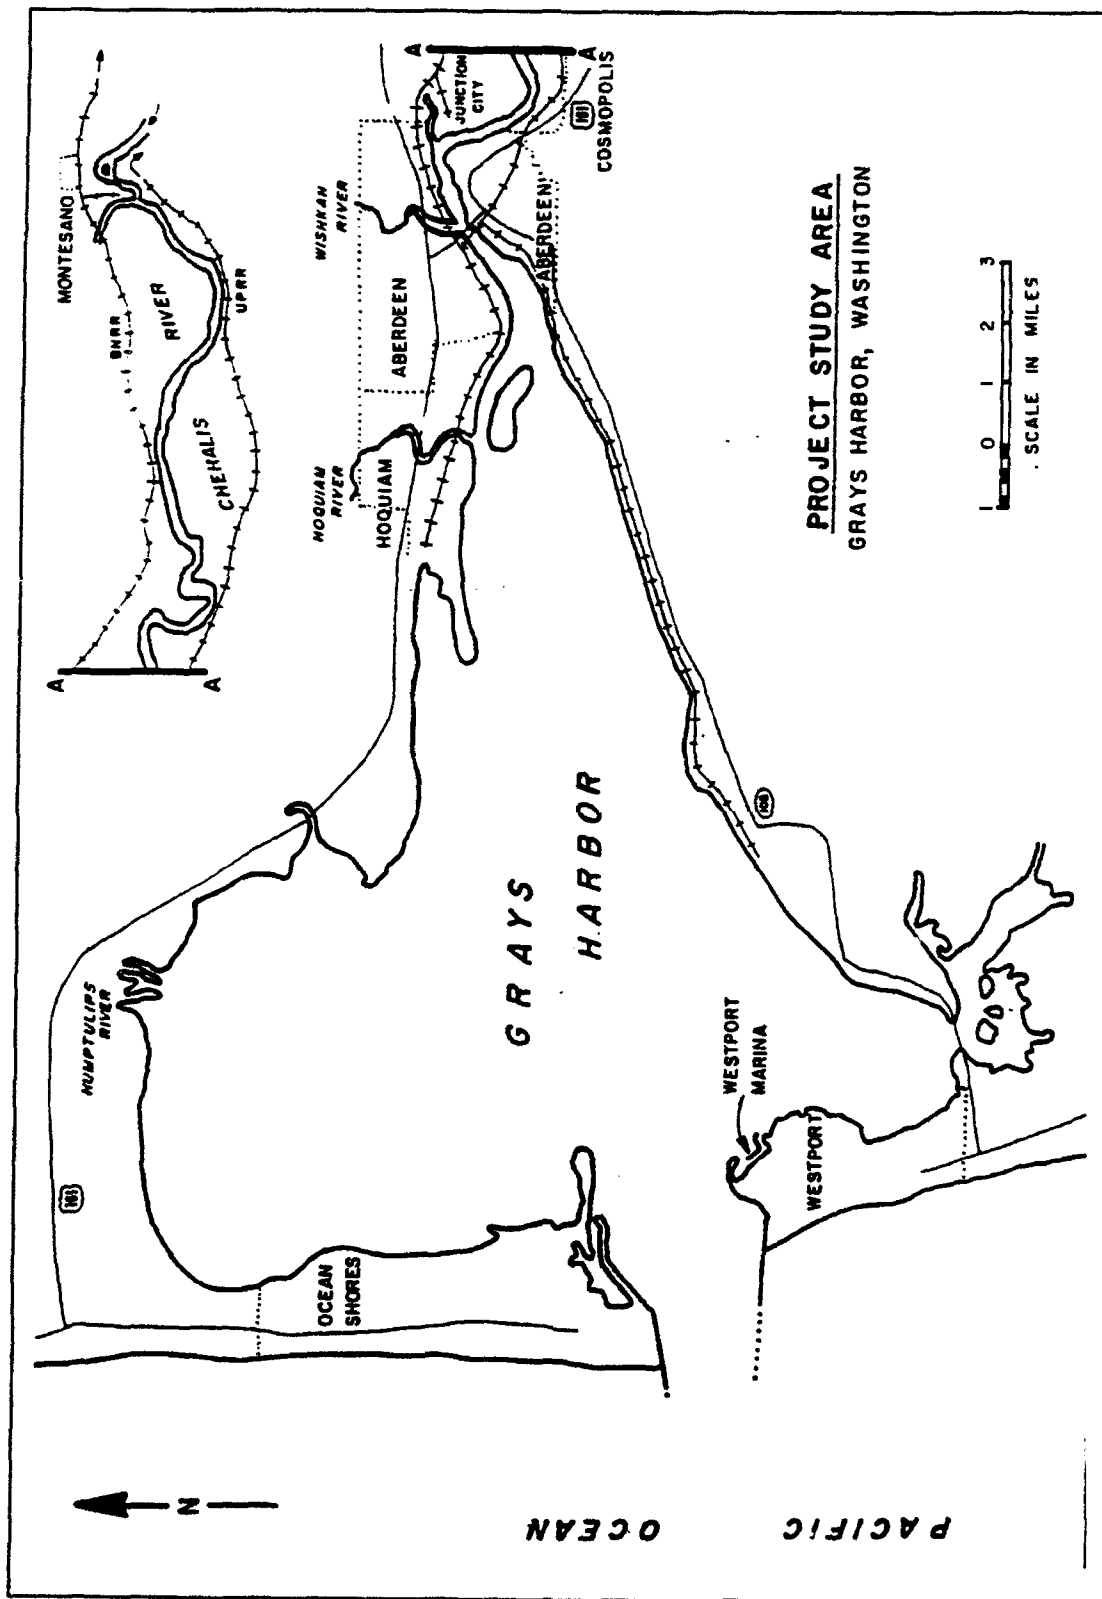
Figure 40. Grays Harbor, Washington, site location map

The jetties have modified the natural tidal circulation patterns of the entrance channel. The ebb currents exit along the southern portion of the entrance, which has caused deep scour against the south jetty from Point Chehalis seaward across the outer bar. Currents have at times scoured the southern 2,000 ft of entrance to depths greater than -70 ft mllw (U.S. Army Corps of Engineers 1988). This has caused undermining and failure of the jetty as well as increasing bar depths from about -15 ft to -35 ft mllw (from construction to present day). Ebb currents have been measured at 3.0 to 4.0 ft/sec, with a tide range greater than 8 ft.

The jetties have also undergone subsidence believed to be caused by the thick sand foundation supporting the structures. Storm waves with heights of 30 ft and greater cause percolation through the sandy foundation. This,

coupled with the tremendous weight of the armor units and the high structure elevations, caused the structures to subside.

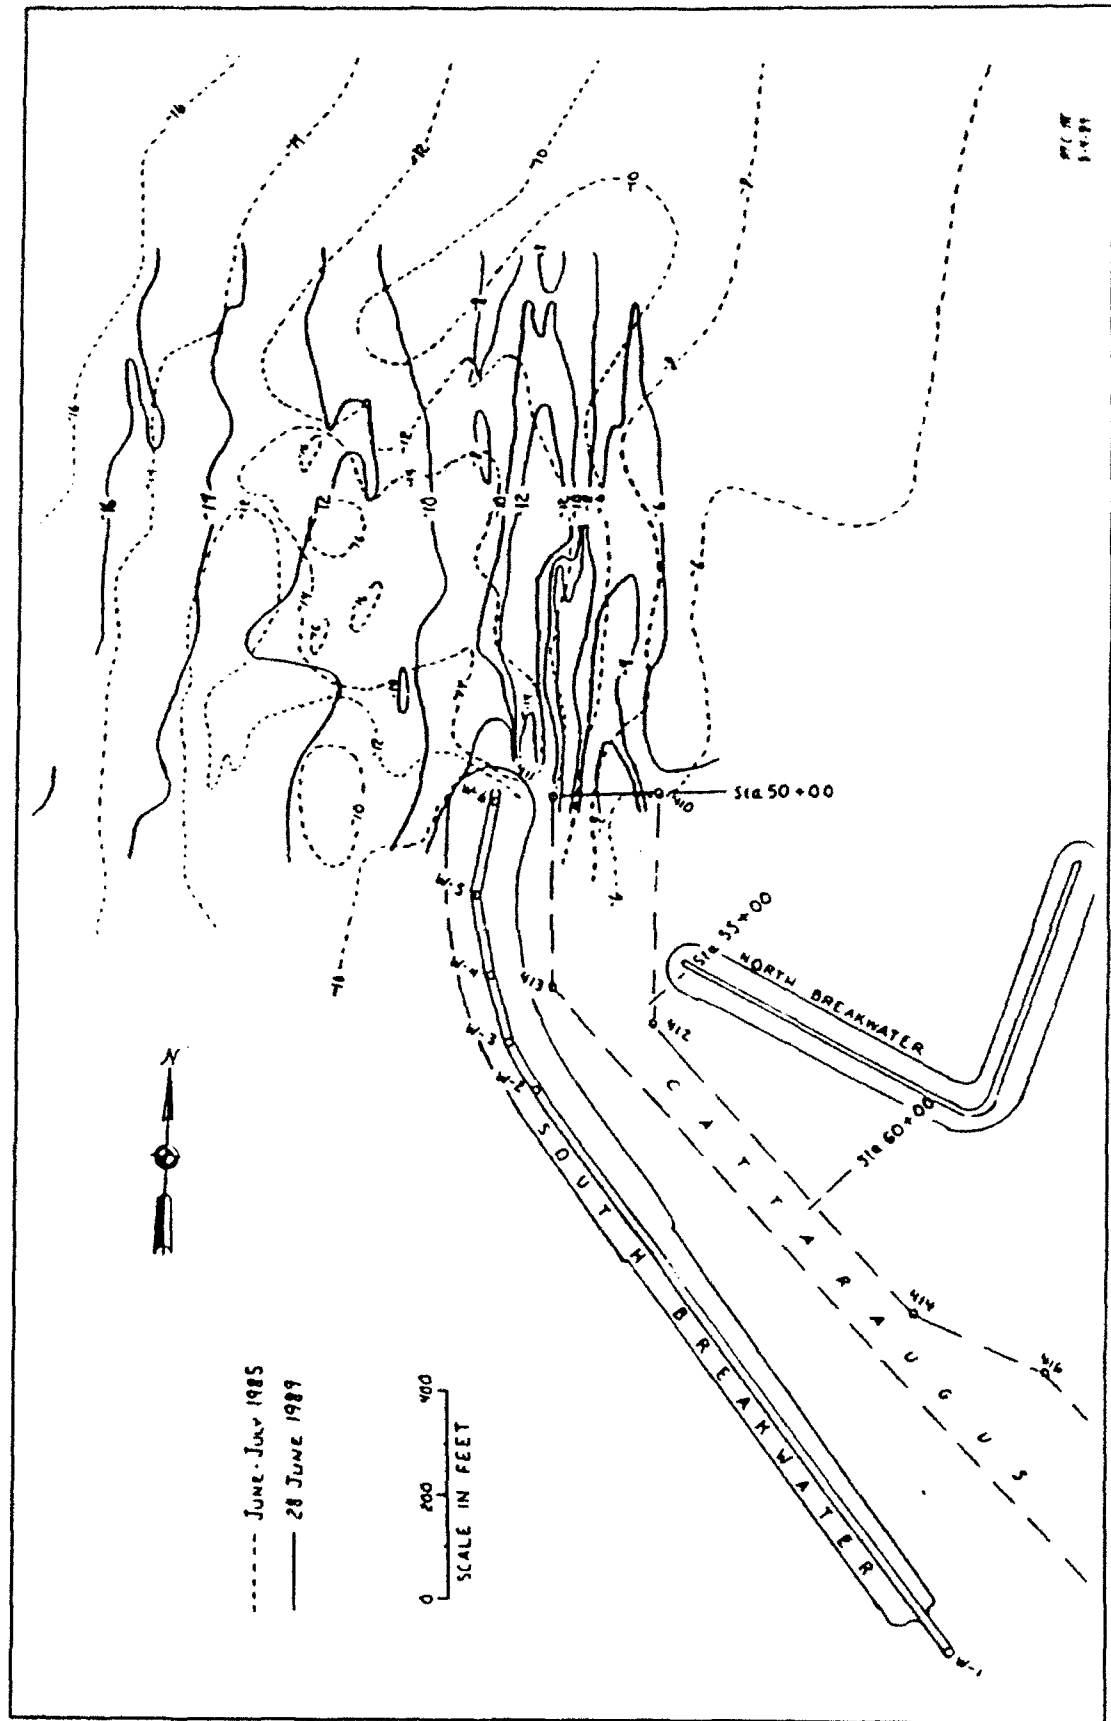
Figure 42. Cattaraugus Harbor, New York, site location map

The MCCP survey data indicated the development of a scour hole that apparently formed shortly after construction (Figure 42). This scour was located off the head of the breakwater structure with approximate dimensions of 800 ft in diameter and a depth of 4 ft below the usual bottom depth in the surrounding area. The scour contours are shown in Figure 42. Subsequently, natural littoral processes have filled in the scour hole to the point that by 1989 the hole was nearly filled in and the depth contours have been straightened. Presently there is no scour hole problem at Cattaraugus Harbor.

During the scour hole episode at Cattaraugus Harbor, the lake was about 1.5 ft above average. It is thought that the scour was a temporary feature resulting from construction of the breakwater, possibly caused by wave reflection from the structure. The high lake levels may have allowed more wave energy closer to shore, also contributing to the scour. The scour was not thought to be related to storm activity.

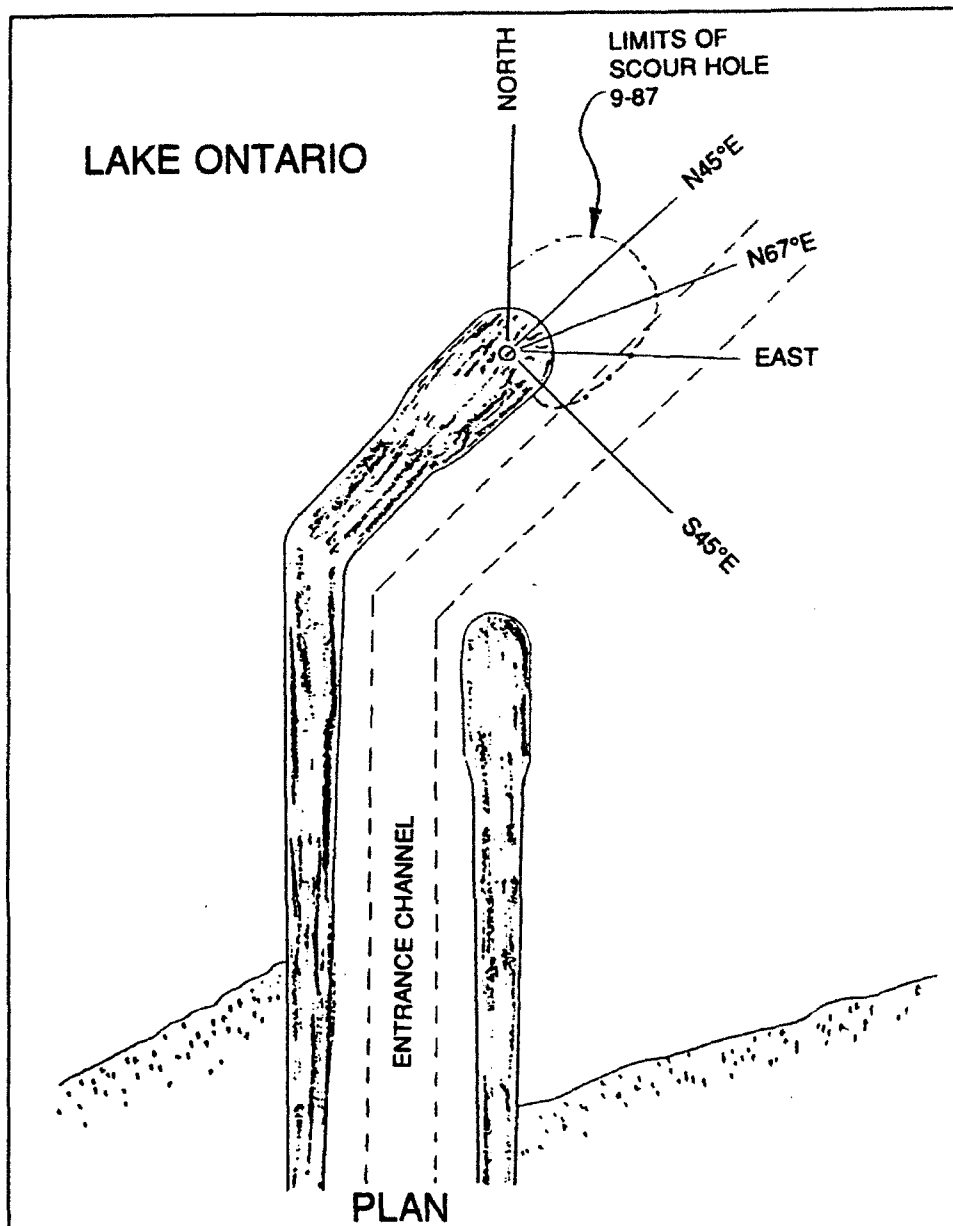
Figure 43. Irondequoit Bay, New York, site location map

Post-construction scour, similar to what occurred at Cattaraugus Harbor, developed at the tip of the west breakwater as shown on Figure 43, only it was more severe, with maximum depths 19 ft below the bottom level of the surrounding area.
